Incident Summary

Location	Building 71 Main Corridor
Detail	MSSB 12455
Equipment	Other
Incident Date	6/11/2010 8:58:27 AM
Diagnosis	No fault
Recommendation	No action
Severity	No-Fault
Units	36.4°C
Global Emissivity	1.00

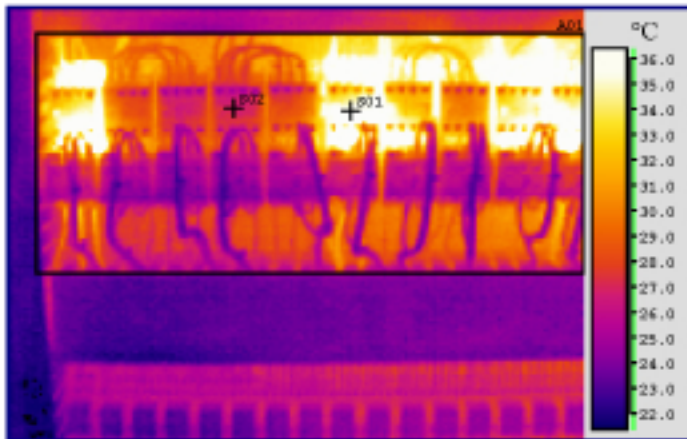
Thermographer	Esafe Technician
Component Temperature	36.4
Reference Temperature	26.7
Temperature Rise	9.6
Component Emissivity	1.00
Background Temperature	8

Spot Meter	Emissivity	Temp*
S01	1.00	36.4
S02	1.00	26.7

MSSB 12455
Located in Building 71, Main Corridor.
Controls, contactors are operating at a normal temperature.

No action is required.
CLASS : E
